SERVICE BULLETIN #5004 - SEPTEMBER, 1985

MODEL: CD391 AND CD491 CASSETTE DECKS

SUBJECT: REEL MOTOR IDLER ASSEMBLY

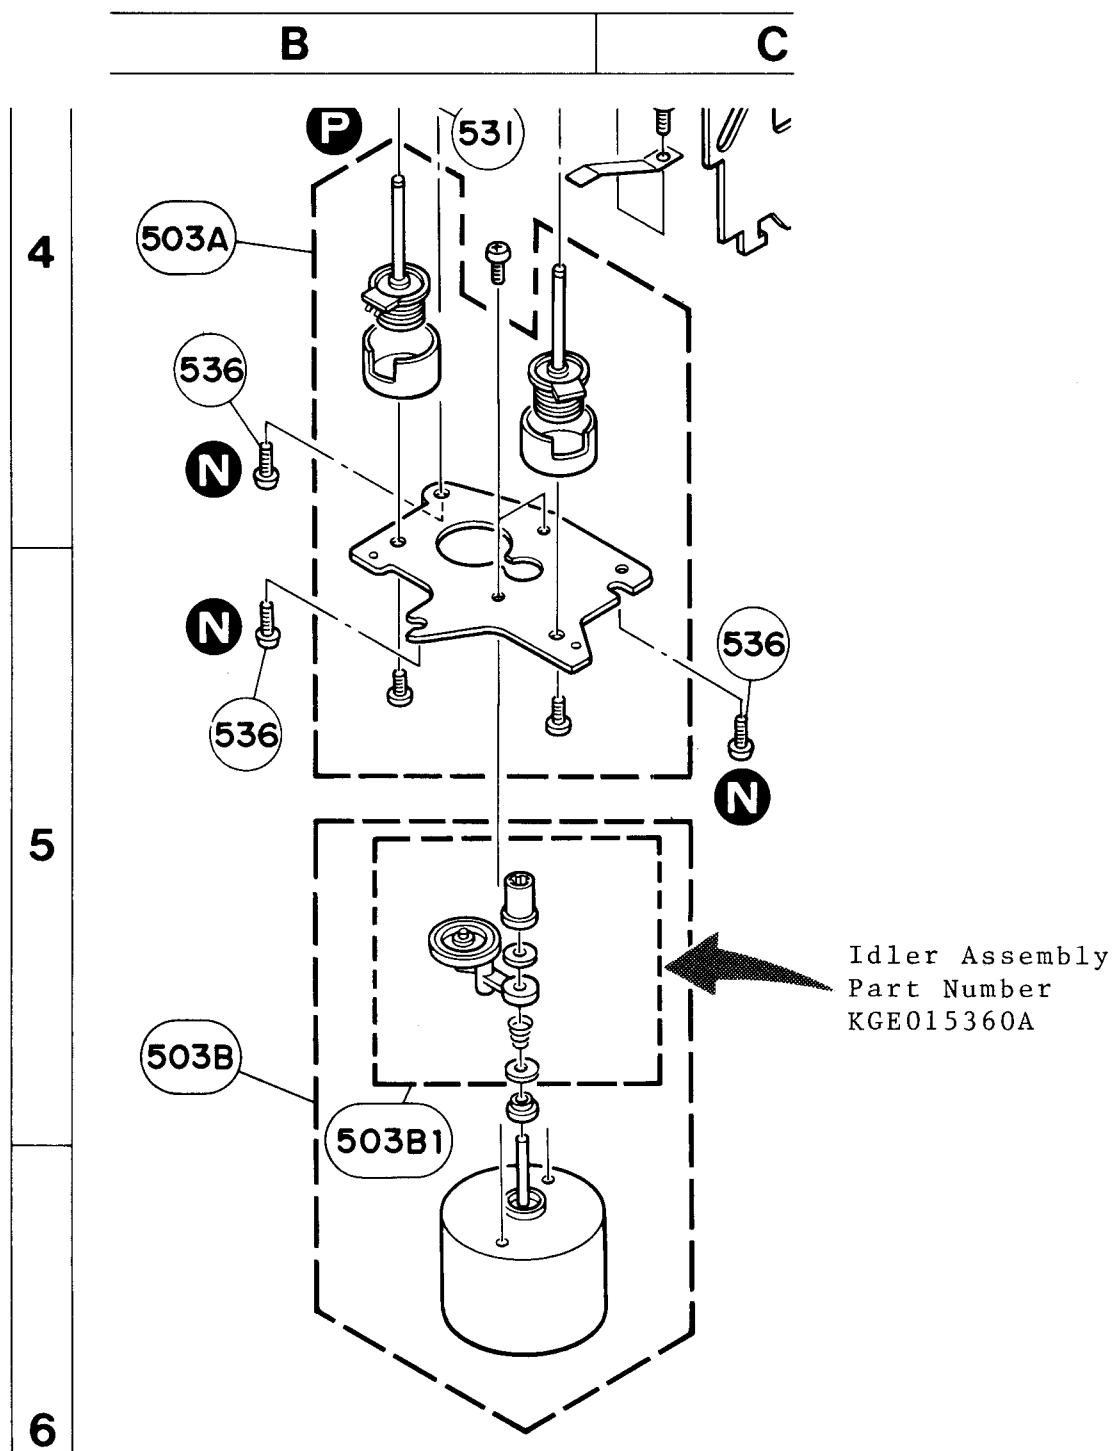
When the white motor pulley is in the correct position, the idler wheel rides in the middle of the drive surface of the right hand reel table.

1. Remove the cabinet top cover screws,
2. Remove the following knobs: Bias Fine Trim, Output Level, Mic Level, Record Level and Master Fader.
3. Remove the screws which hold the front panel in place and remove the front panel.
4. Open the cassette door and remove the two screws which hold the dressing plate in place.
5. Pull the white motor pulley with a pair of pliers and remove it from the motor shaft.
6. Remove the idler assembly 503B1 and replace it with Harman Kardon part number KGE015360A.
7. Push the white motor pulley on to the motor shaft until the top of this pulley is at a distance of 18.7mm (0.736 inch) from the top of the motor enclosure. (Note: If the white motor pulley is pushed on to the motor shaft too far, the idler assembly will tend to bind.)
